**LWG ENVIRONMENTAL AUDIT PROTOCOL
SUMMARY REPORT**

**Annai Fathima Leathers
No.25, Old Thiruthani road
Ranipet - 632 401
Ranipet Dist., Tamil Nadu
INDIA**

September 2020

AUDIT REPORT

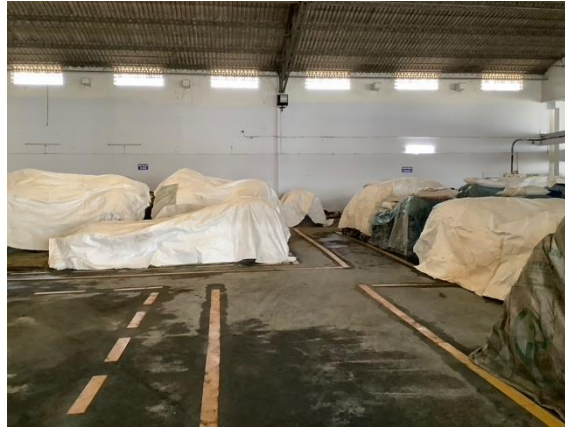
Figure 3: Wetblue store

Housekeeping is performed well, but the tannery can improve further. The score in this section is Bronze. In order to get higher score, the tannery should improve housekeeping, particularly wherever the score is lesser than the maximum. It is recommended to the tannery to install active guard in the fleshings machine in addition to the emergency switches.

- Supplier documentation on compliance to own specifications should be obtained including bulk chemicals, if compliance tests are not performed by the tannery.
- Storage of wastes can be improved further.
- In order to get higher score in housekeeping, the tannery should improve housekeeping, particularly wherever the score is lesser than the maximum. It is recommended to the tannery to install active guard in the fleshings machine in addition to the emergency switches.
